RE: WATER QUALITY ANALYSIS AND DAM INSPECTION RESULTS

July 6, 2007

Aquatic Environmental Services, Inc. conducted a water quality analysis including fecal coliform, and dam and outlet pipe inspection survey on June 14th, 2007 at 12:30 PM at **Providence** lake. The data collected from this study was analyzed and used to describe the current conditions of the water, uses, and physical structure of the dam and draining pipe. Based on these results, recommendations are made to correct lake issues.

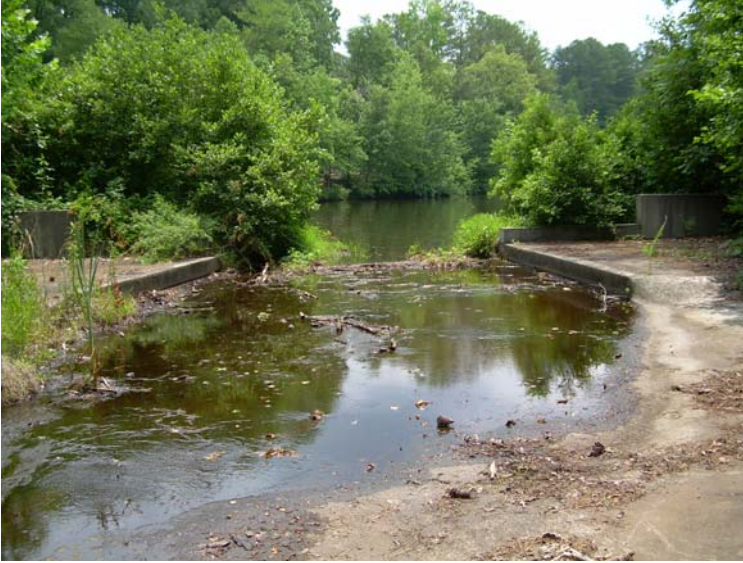
Spillway Width/Integrity: ~27 feet wide. Concrete spillway without trash rack in good shape (Figure 1).

Figure 1. Concrete spillway. It looks in good shape and almost free of debris.

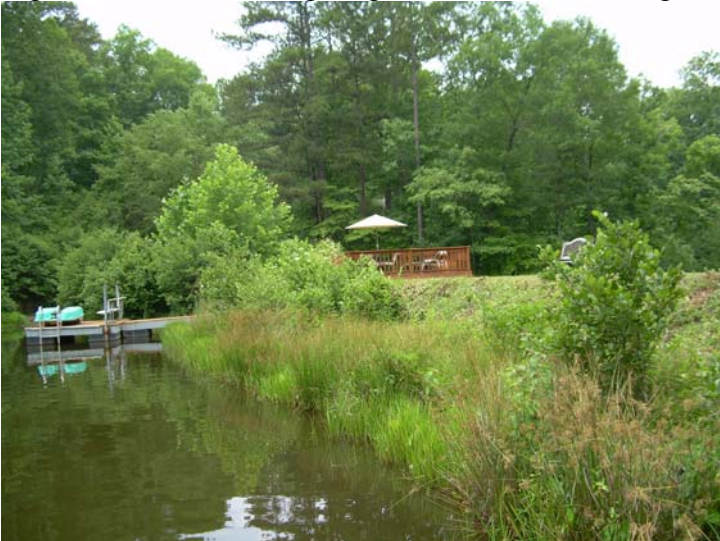
Dam Vegetation: The dam was in good shape and covered by short grass on the top and back part. However, about 50% of the internal slope was invaded by weeds (emergent grass) and shrubs (hazel alder) (Figure 2).

Figure 2. Observe emergent grass and short shrubs growing on the internal slope of dam.

Evaluation and Recommendations: The physical structure of the dam and lake are in good working condition. However, control the grass growing on the waterline in front of the dam. Although these plants do not cause any physical damage to the dam structure, they can be very invasive and they reduce the aesthetic value of the lake. The shrubs (few hazel alder observed on the dam) must be removed. In the present time they do not damage the dam, but over time they will grow and their roots will cause damage. Feel free to hire a landscape crew to remove the vegetation. We also provide this service but only during the months of December to February.

In general water quality is adequate for production of fish. Also the fecal coliforms test indicates that water quality is safe for recreational activities. The physical structure of the dam and lake are in good working condition. Remove or control the undesirable vegetation on the the dam. If you have any question or need more information about issues discussed in this report, please feel free to contact us.
